# BOLTED FIELD REPAIR OF COMPOSITE STRUCTURES

J. C. Watson, et al.  
McDonnell Douglas Corporation  
McDonnell Aircraft Company  
P.O. Box 516  
St. Louis, Missouri 63166

Final Report

Repairs were demonstrated on both laminate thicknesses. The 3/16 inch laminate was typical of an AV-8B wing skin. The 1/2 inch laminate was typical of an F-18 wing skin. Three sizes of damage holes were investigated for each laminate thickness: 1.0 in., 2.5 in., and 4.0 in. diameters. Two repair concepts were evaluated for each damage configuration.

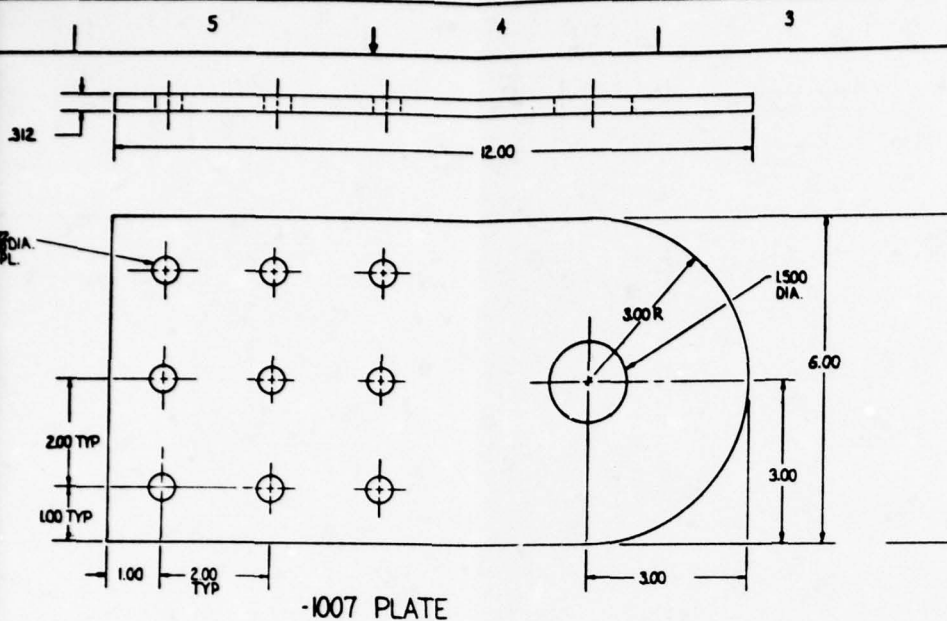
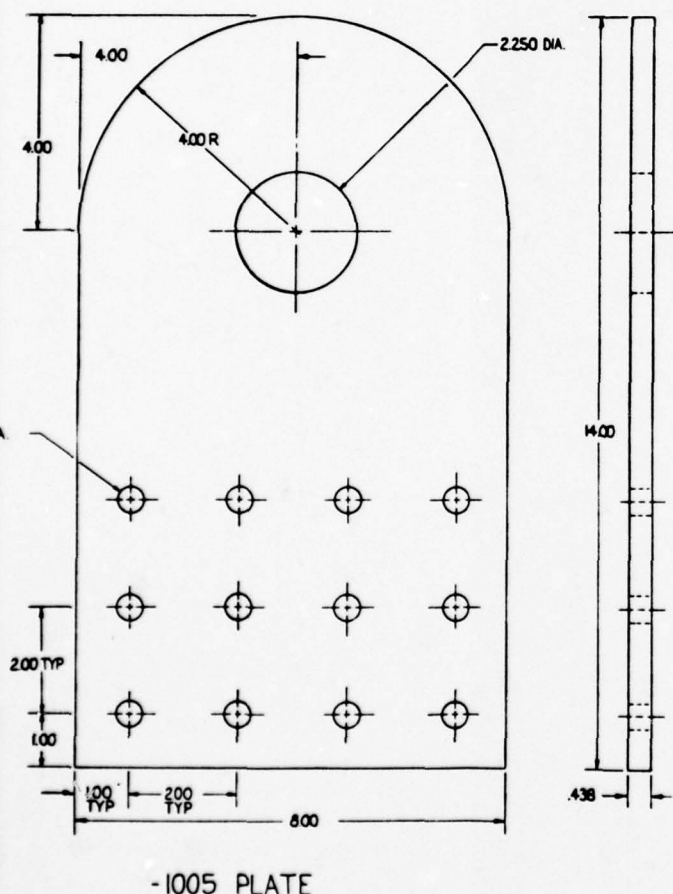
FIGURE A-2 DETAILED DRAWING OF LOAD PLATES FOR COMPOSITE REPAIR LAMINATES

-1009 BLOCK

FIGURE NO	MCAIR DWG NO	TITLE
A-1	75T060101	Composite Specimens
A-2	75T060102	Load Plates
A-3	75T060103	Repair Patches for 3/16 Laminates
A-4	75T060104	Repair Patches for 1/2 Laminates
A-5	75T060105	Repair Assemblies for 3/16 Laminates
A-6	75T060106	Repair Assemblies for 1/2 Laminates
A-7	75T060107	Compression Specimen Edge Supports

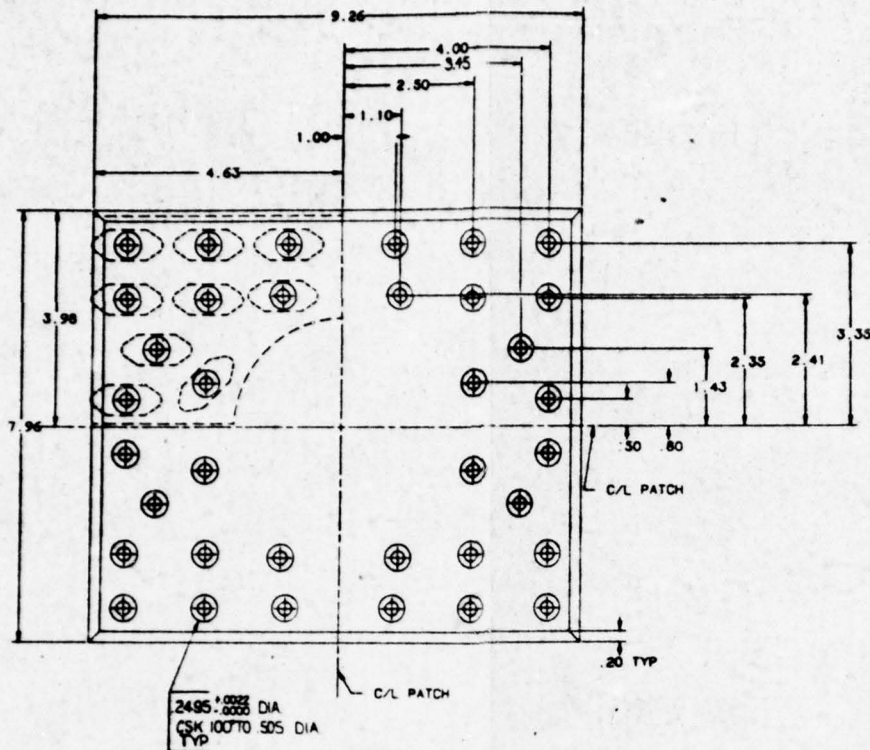
-2005 PATCH

Ⓐ -2013 PATCH  
SAME AS -2005 EXCEPT

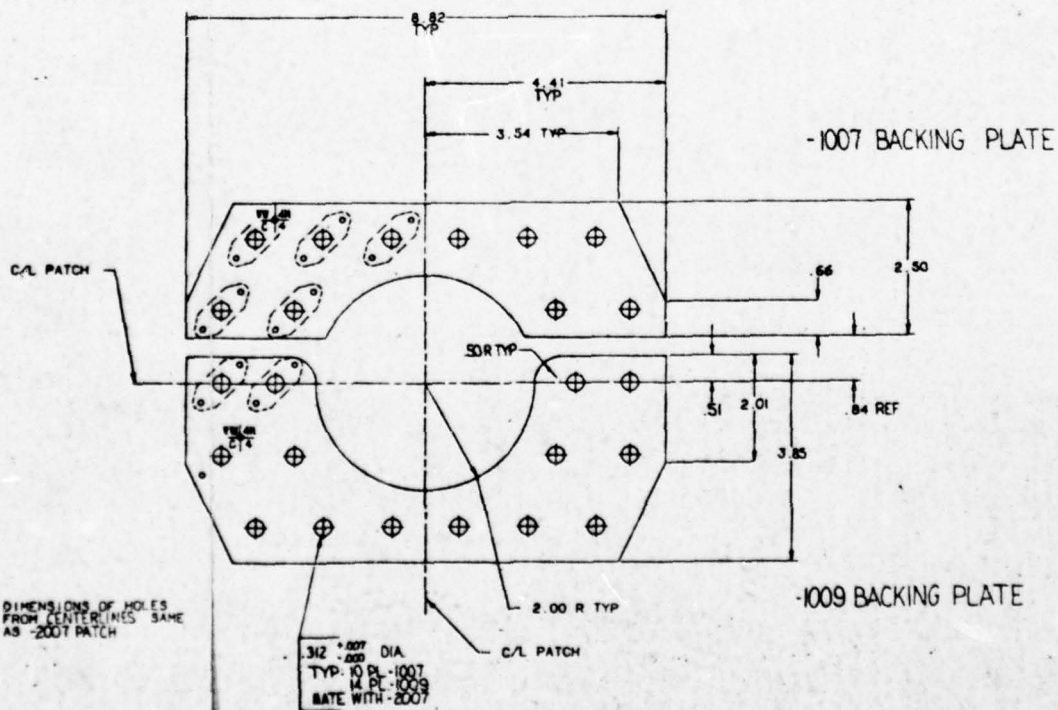
NOTE: DIMENSIONS OF HOLES FROM CENTER LINES SAME AS -2007 PATCH

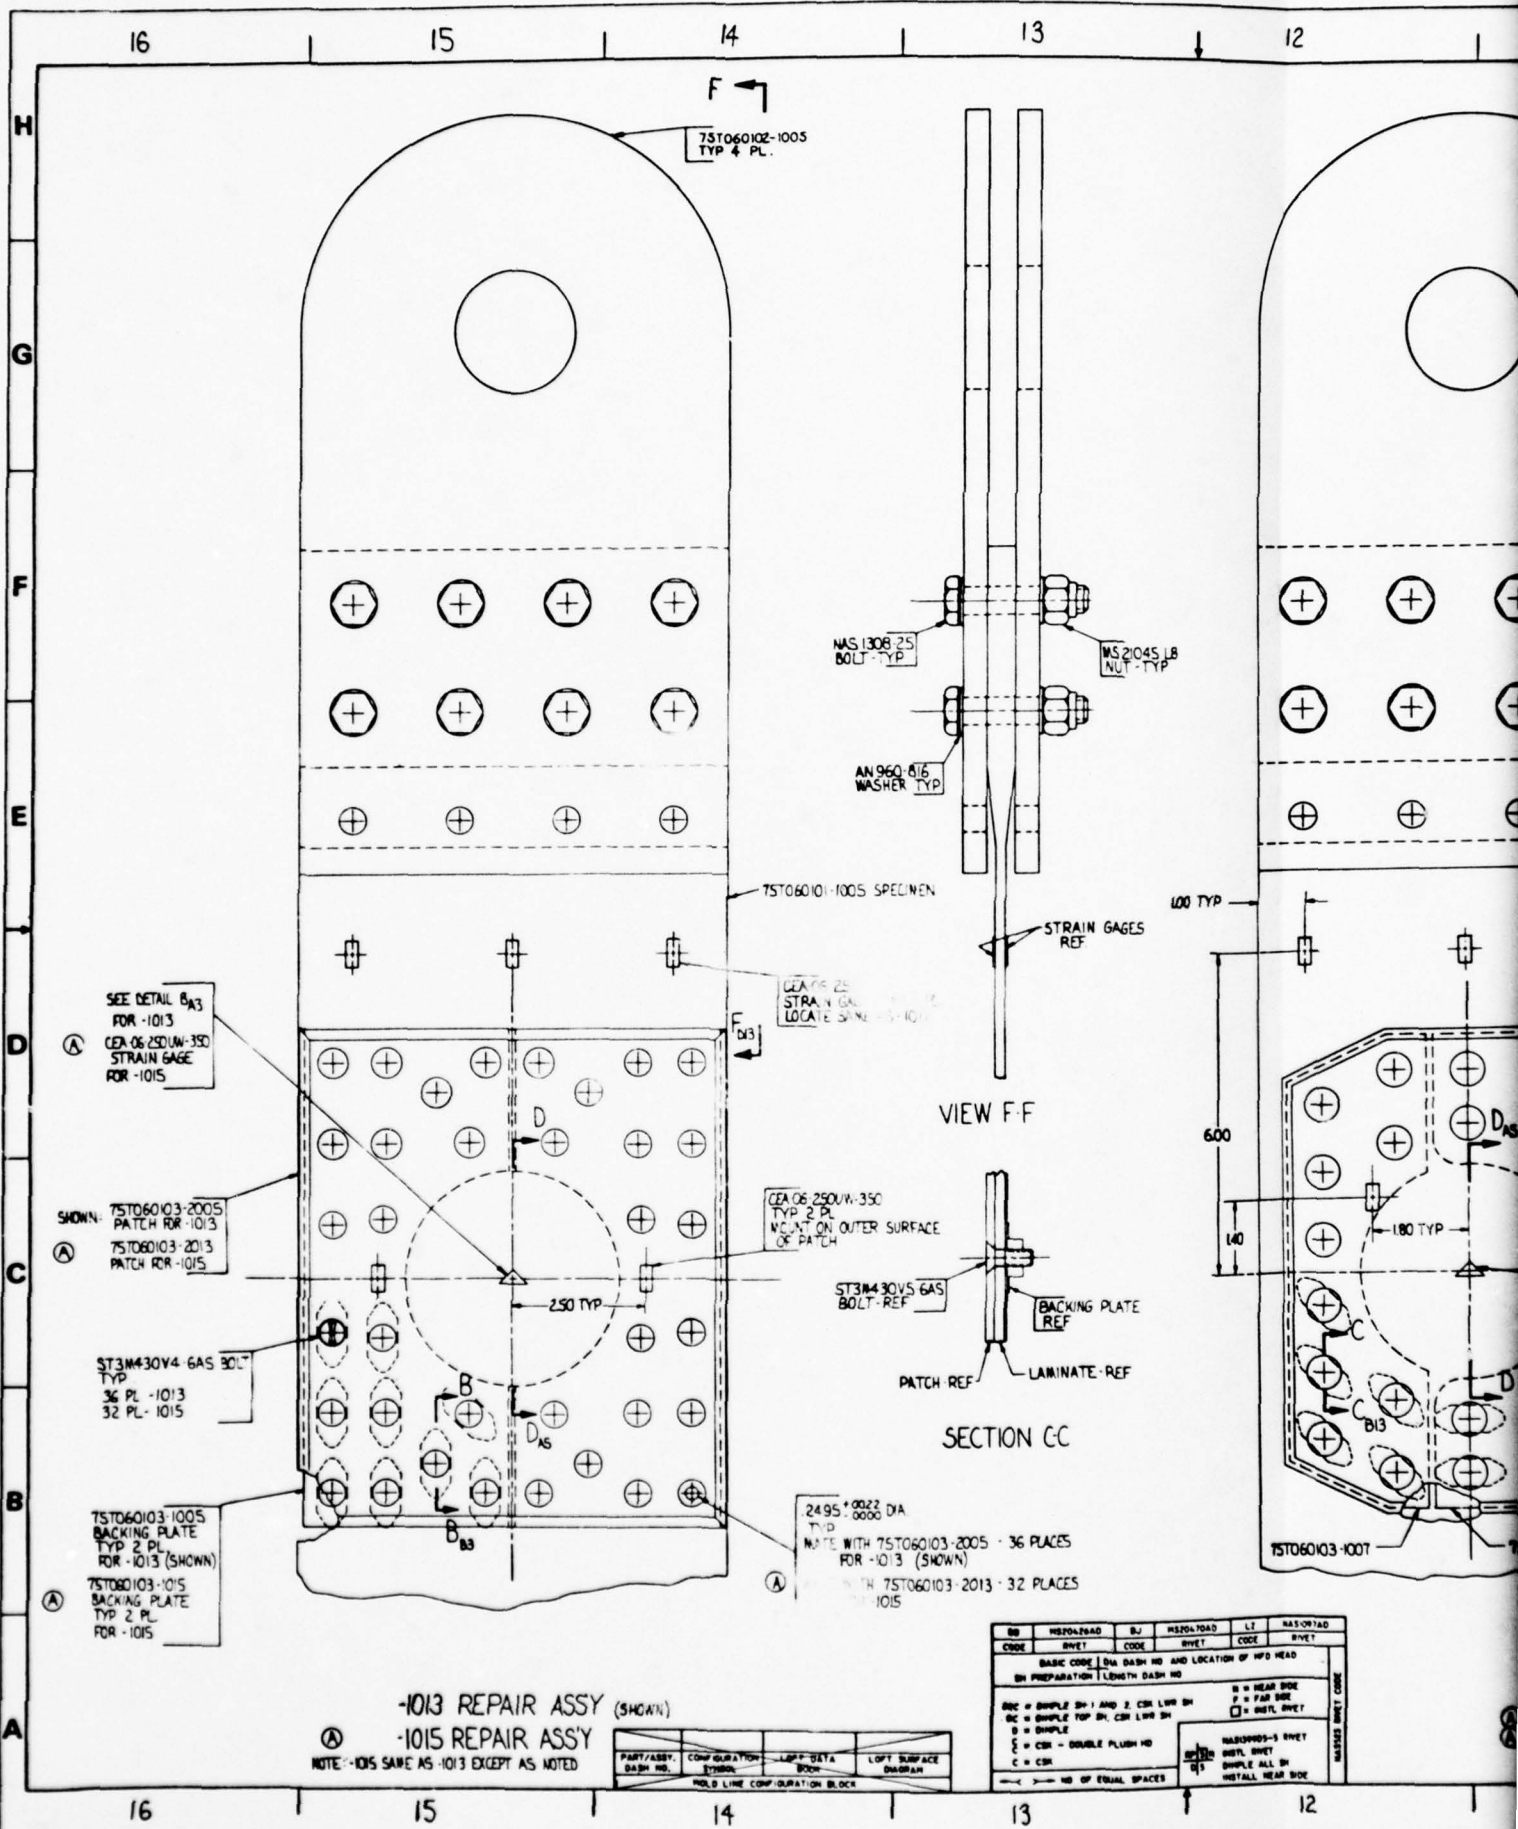
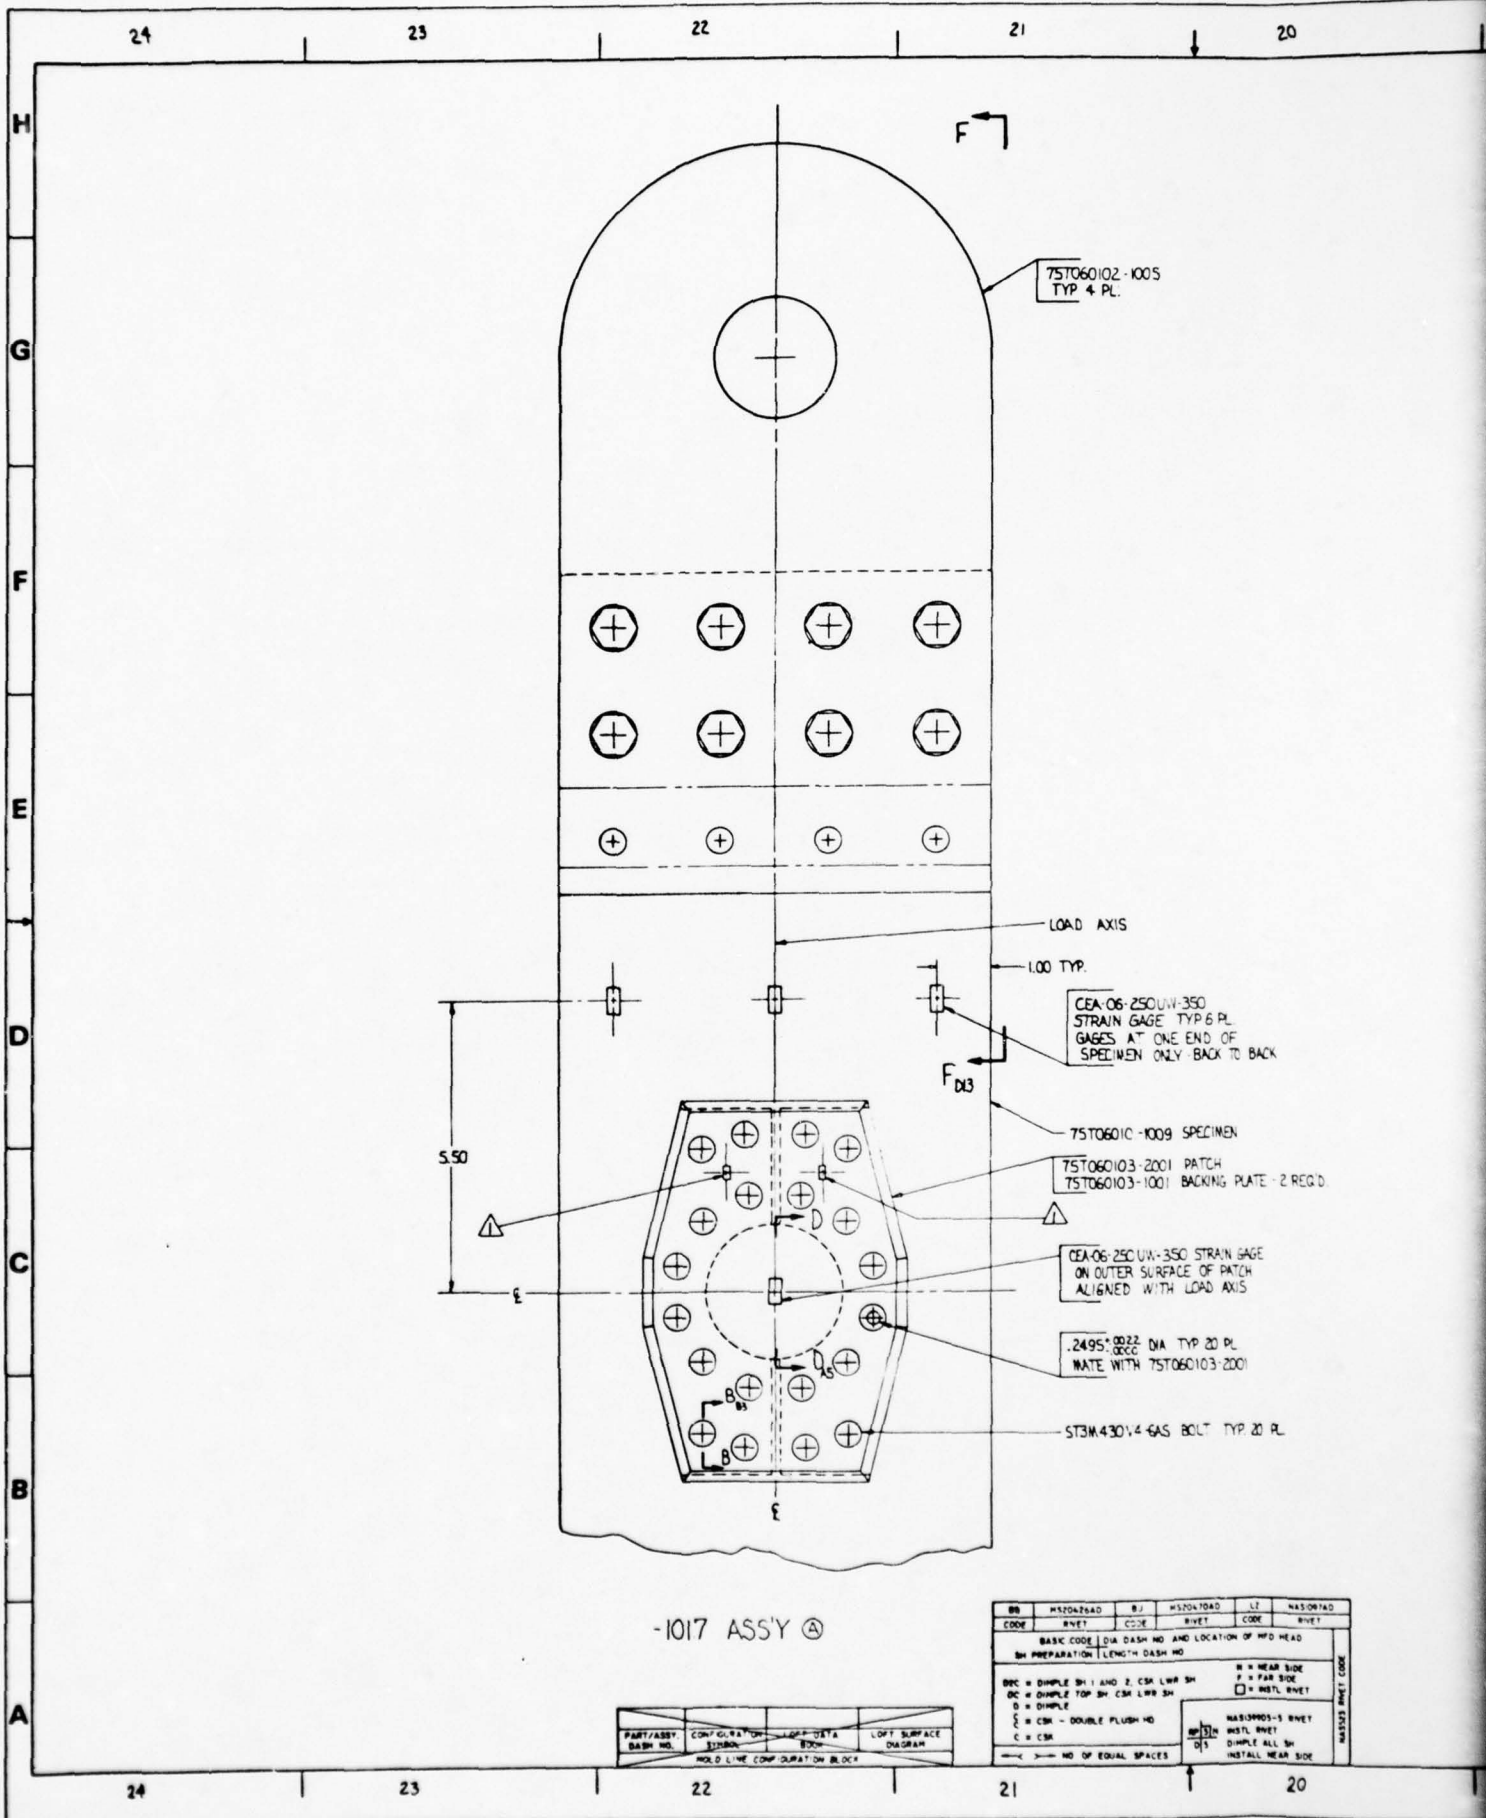
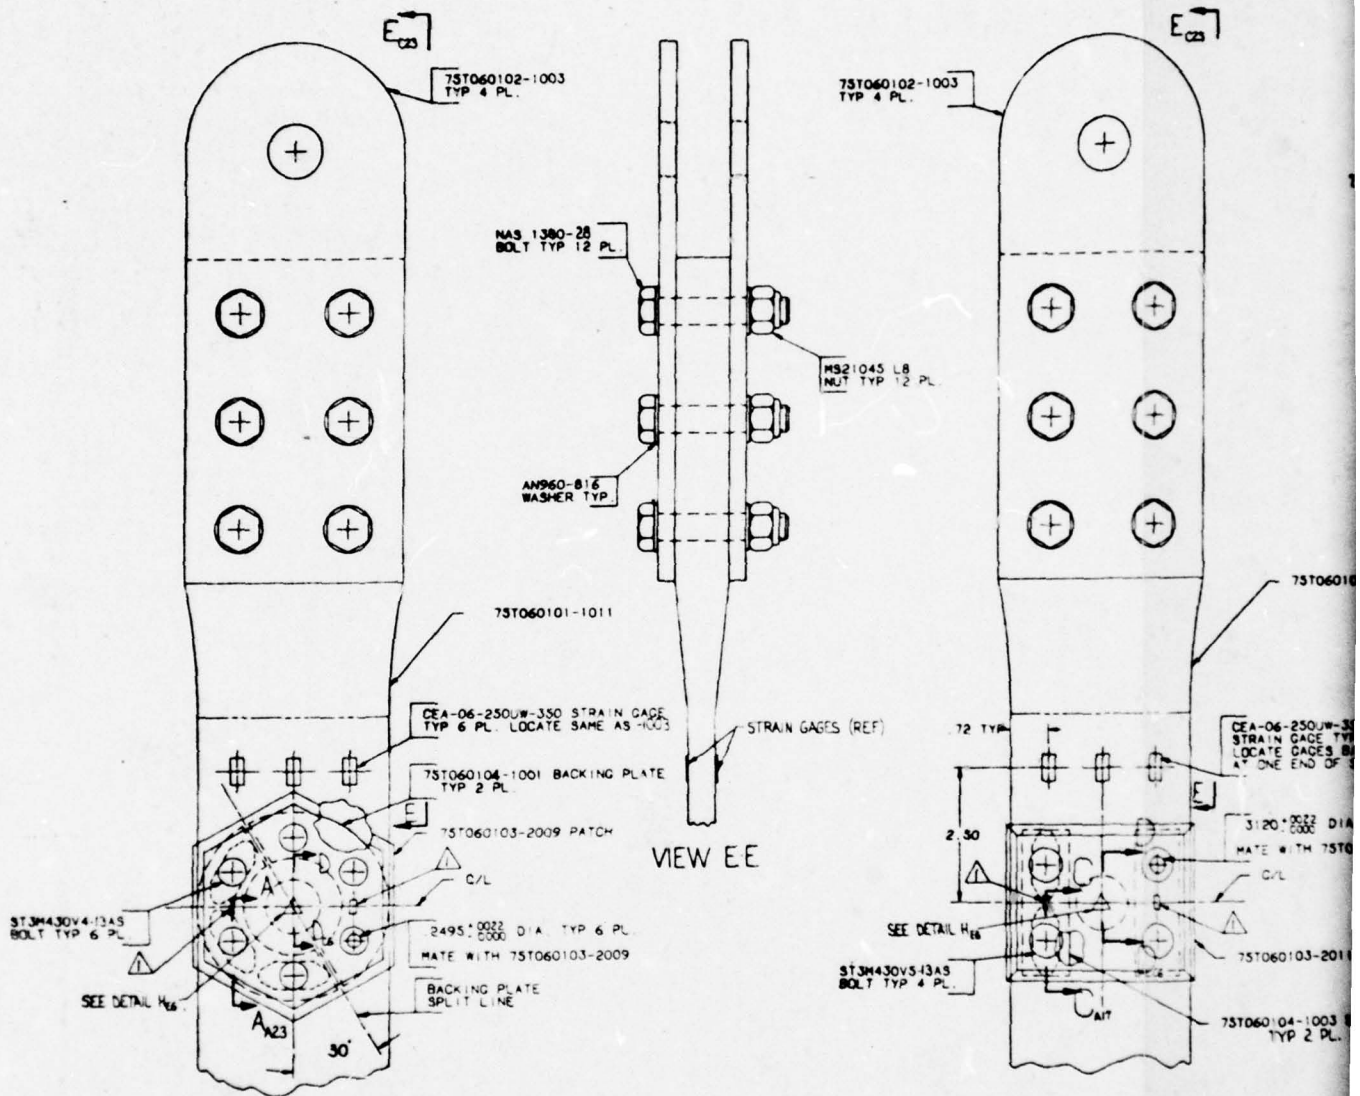
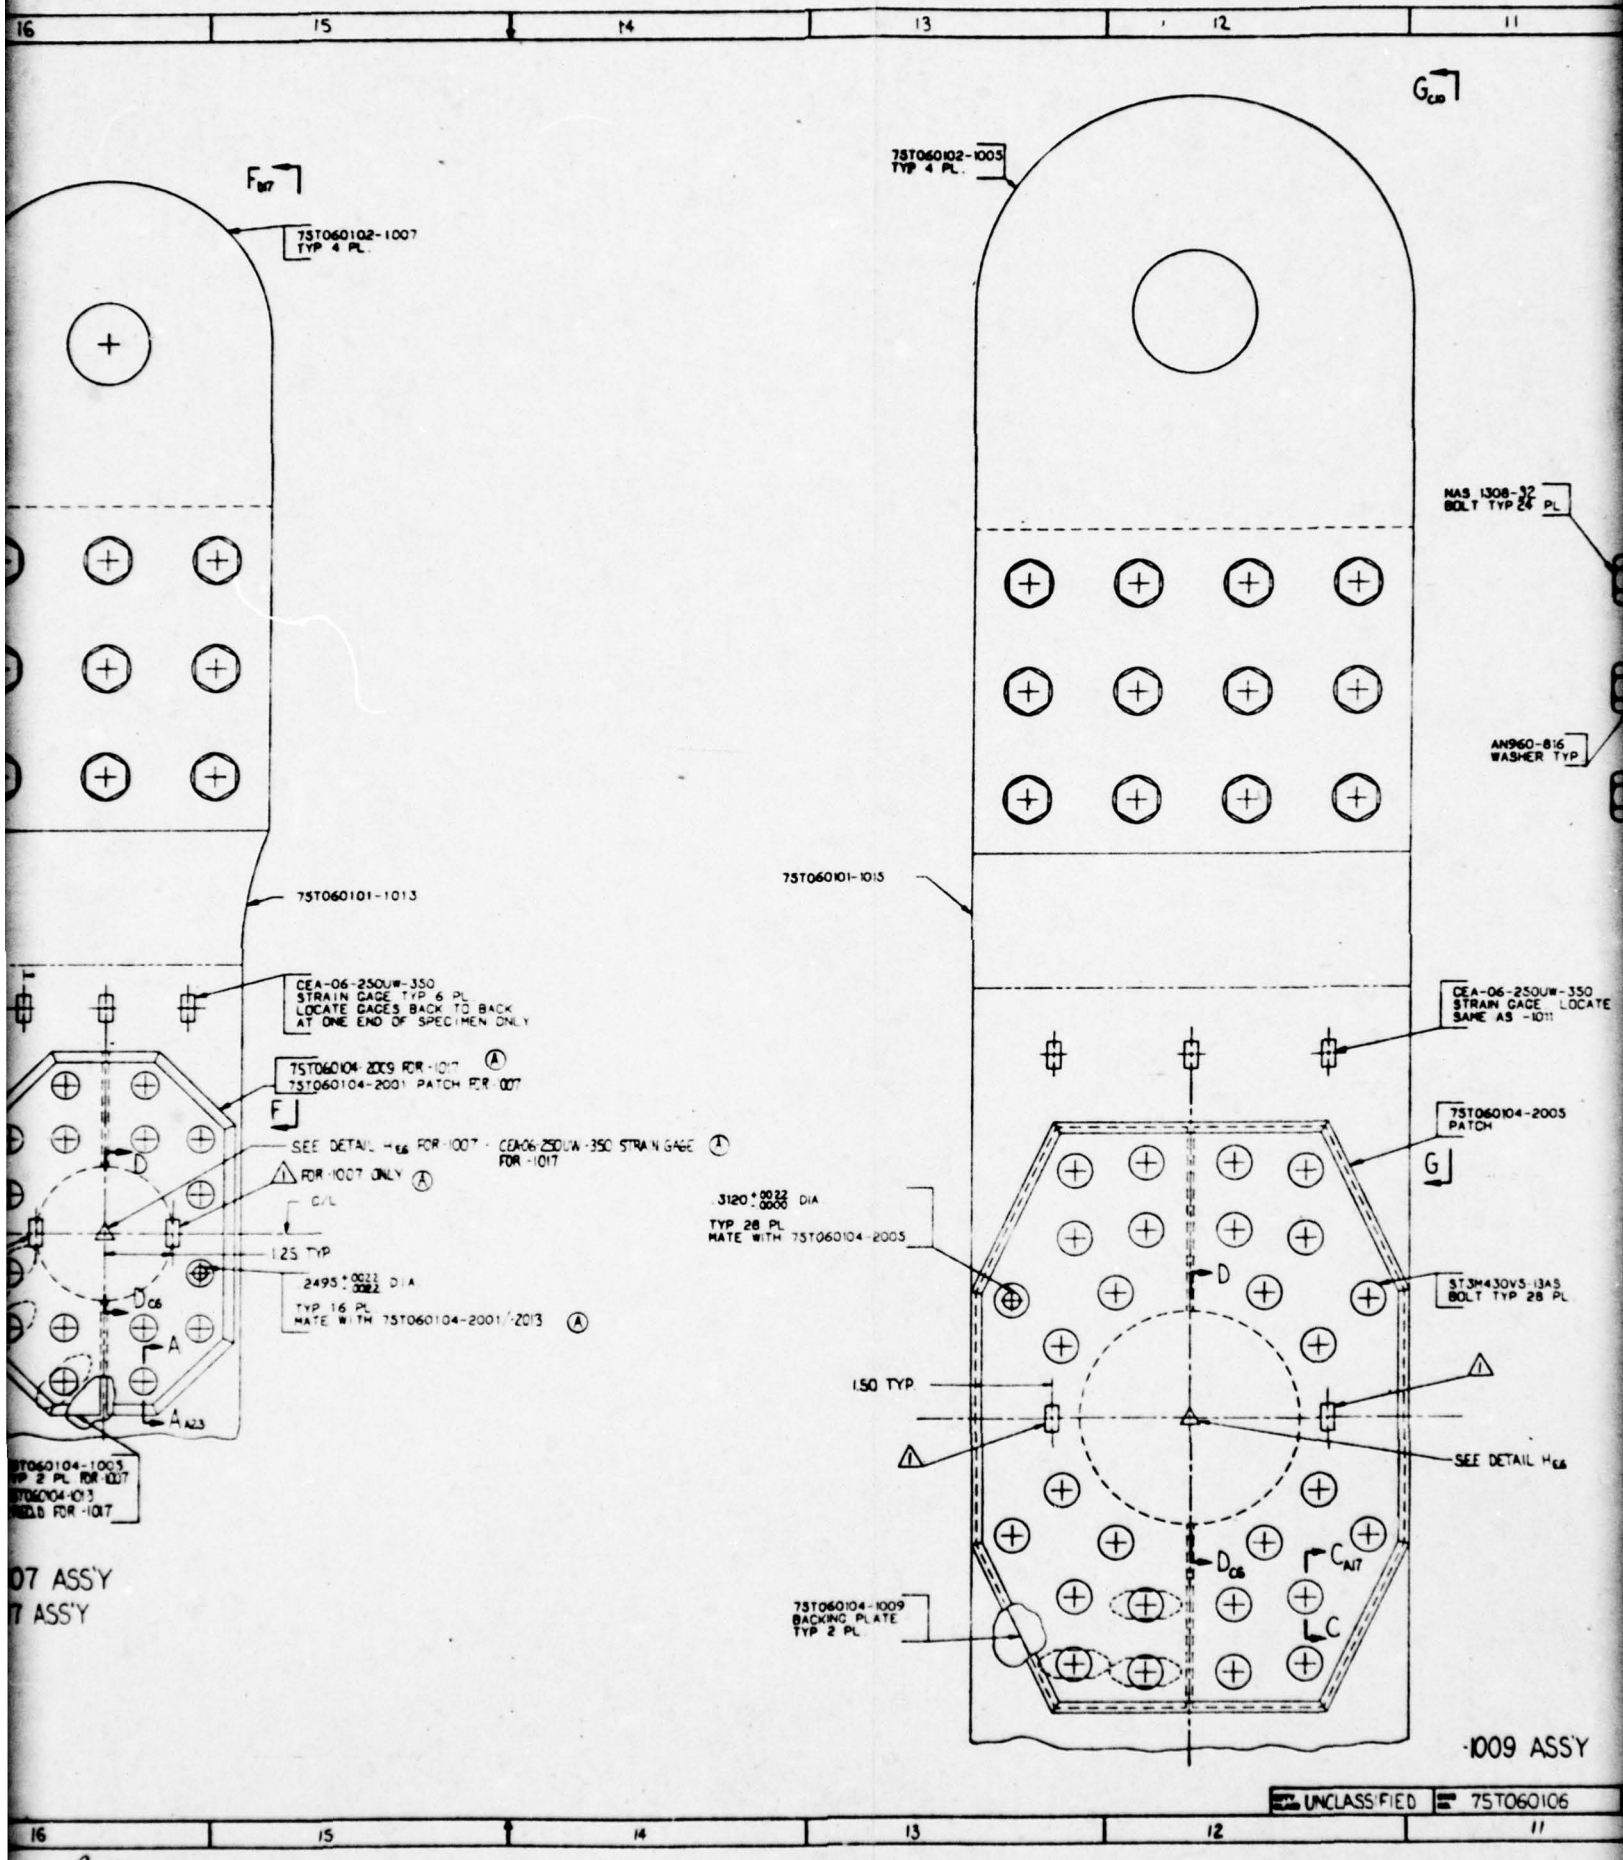
FIGURE A-6 DETAILED DRAWING OF REPAIR ASSEMBLIES  
FOR 1/2 LAMINATES  
A-11

SECTION A-A

▲ BOLTS MAY BE RE-USED ON MULTIPLE TEST ARTICLES.  
▲ ACCEPTABLE ALTERNATE STAINLESS-32 USE WASHERS TO COMPENSATE FOR ANY EXCESS BOLT LENGTH.  
▲ CEA 60125UW-35C STRAIN GAGE MOUNTED ON OUTER SURFACE OF PATCH TYP 2 PLACES AS SHOWN

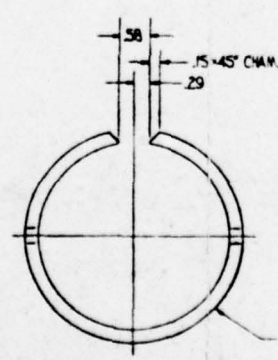
SECTION B-B

(PANEL OMITTED FROM THESE SECTIONS)

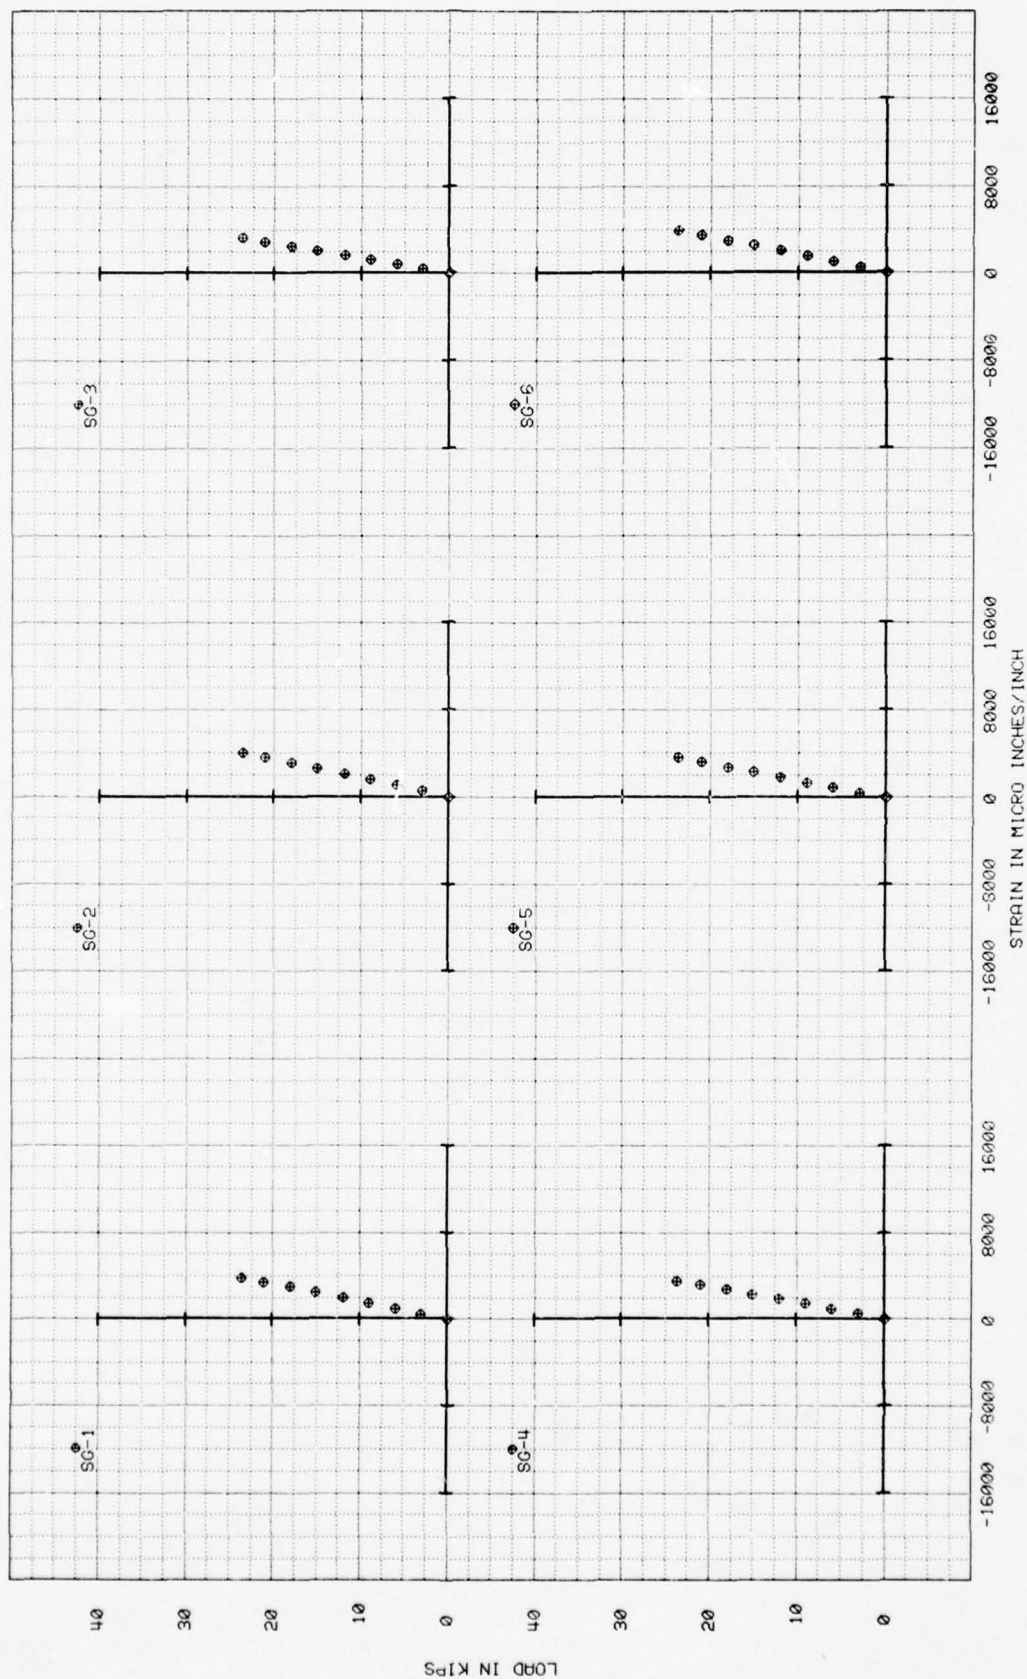
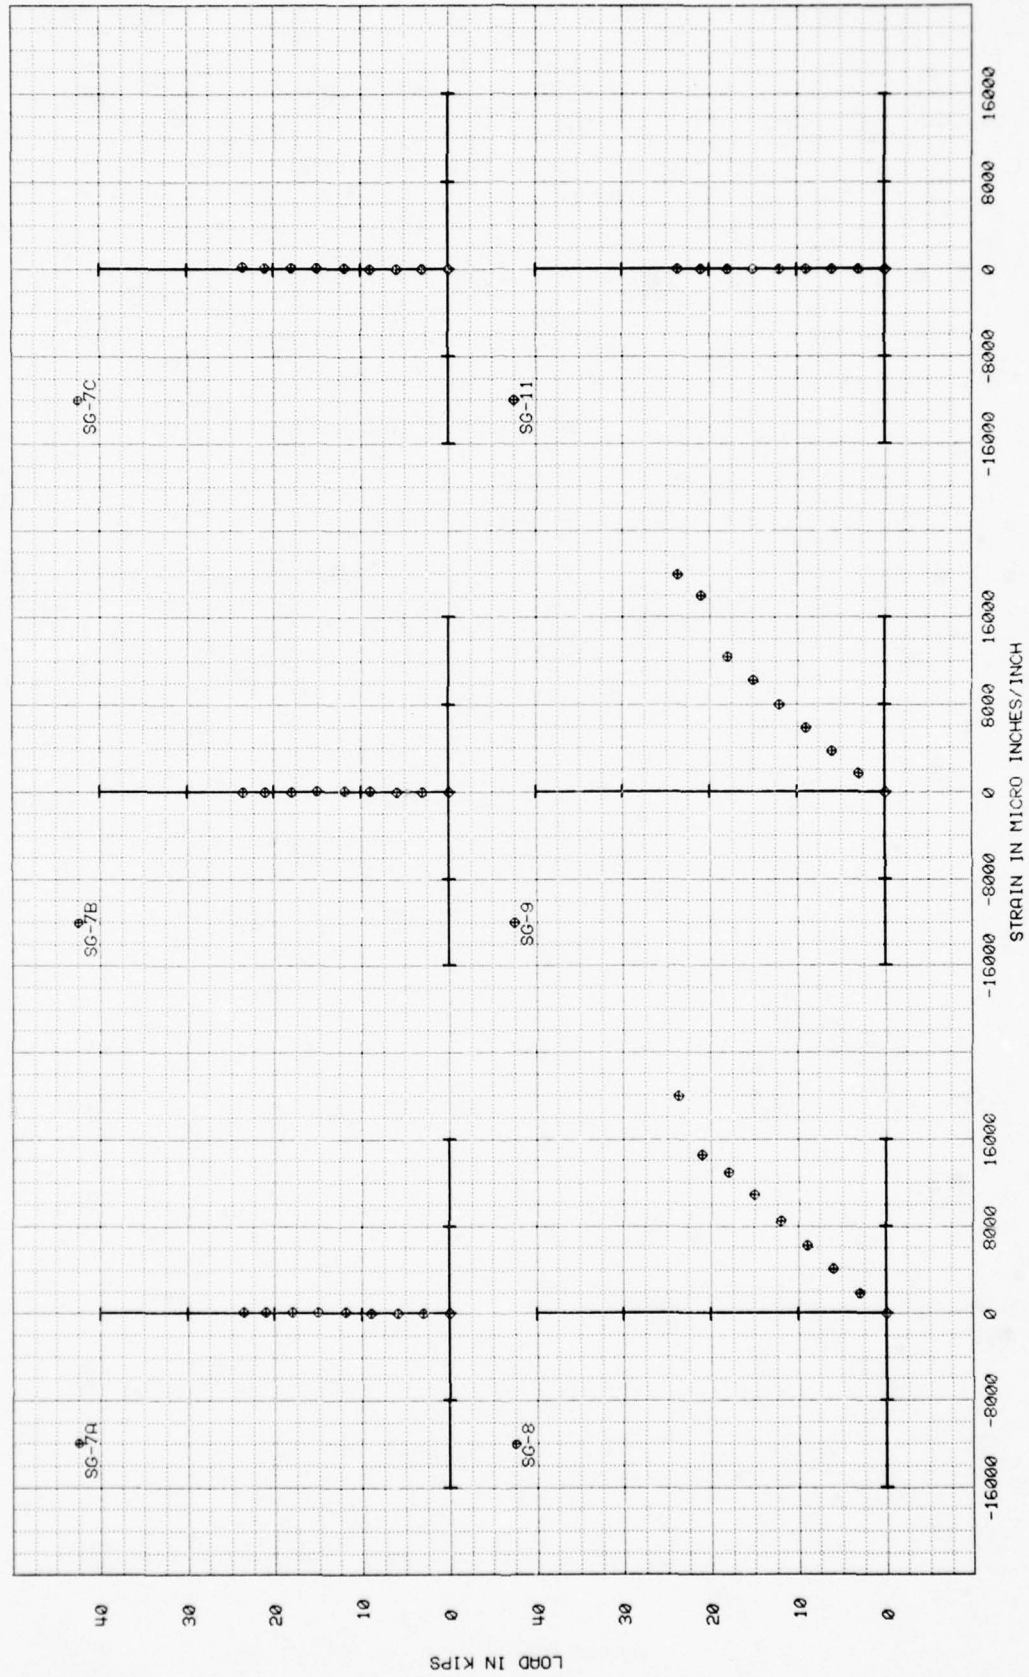
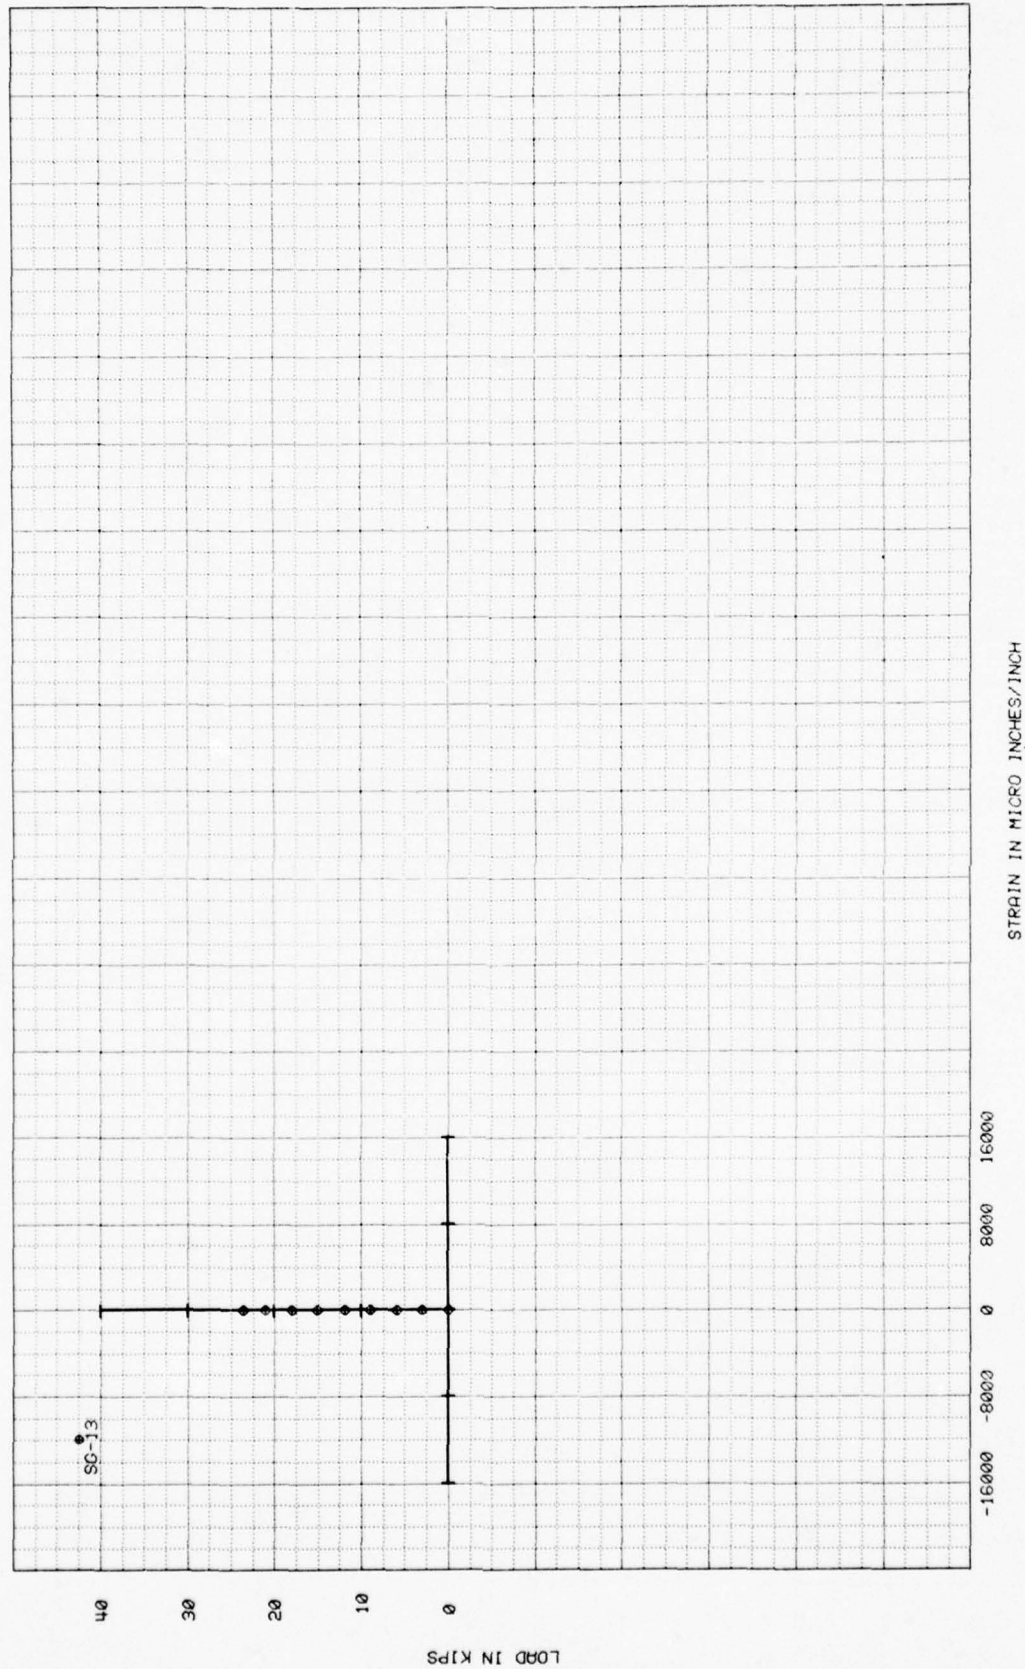
FIGURE B-1 Strain Gage Data 75T060105-1001  
3/16 Laminate 1.0 Dia Damage Hole

FIGURE B-1 Continued Strain Gage Data 75T060105-1001  
3/16 Laminate 1.0 Dia Damage Hole

FIGURE B-1 Continued Strain Gage Data 75T060105-1001  
3/16 Laminated 1.0 Dia Damage Hole

FIGURE NO	TEST SPECIMEN NO	DESCRIPTION OF SPECIMEN
B-1	75T060105-1001	3/16 Laminate
B-2	75T060105-1003	1.0 Diameter
B-3	75T060105-1019 #1	Damage Hole
B-4	75T060105-1019 #2	
B-5	75T060105-1005 #1	3/16 Laminate
B-6	75T060105-1007	2.50 Diameter
B-7	75T060105-1005 #2	Damage Hole
B-8	75T060105-1005 #3	
B-9	75T060105-1011	3/16 Laminate
B-10	75T060105-1013	4.0 Diameter
B-11	75T060105-1015 #1	Damage Hole
B-12	75T060105-1015 #2	
B-13	75T060105-1017	3/16 Laminate Off-Axis
B-14	75T060105-1009	3/16 Laminate Compression
B-15	75T060106-1019	1/2 Laminate
B-16	75T060106-1021 #1	1.0 Diameter
B-17	75T060106-1021 #2	Damage Hole
B-18	75T060106-1021 #3	
B-19	75T060106-1005	1/2 Laminate
B-20	75T060106-1007 #1	2.50 Diameter
B-21	75T060106-1007 #2	Damage Hole
B-22	75T060106-1017
